Periodic Inspection of Nawiliwili Harbor Breakwater, Kauai, Hawaii

Armor Unit Monitoring for Period 1995-2001

Final report

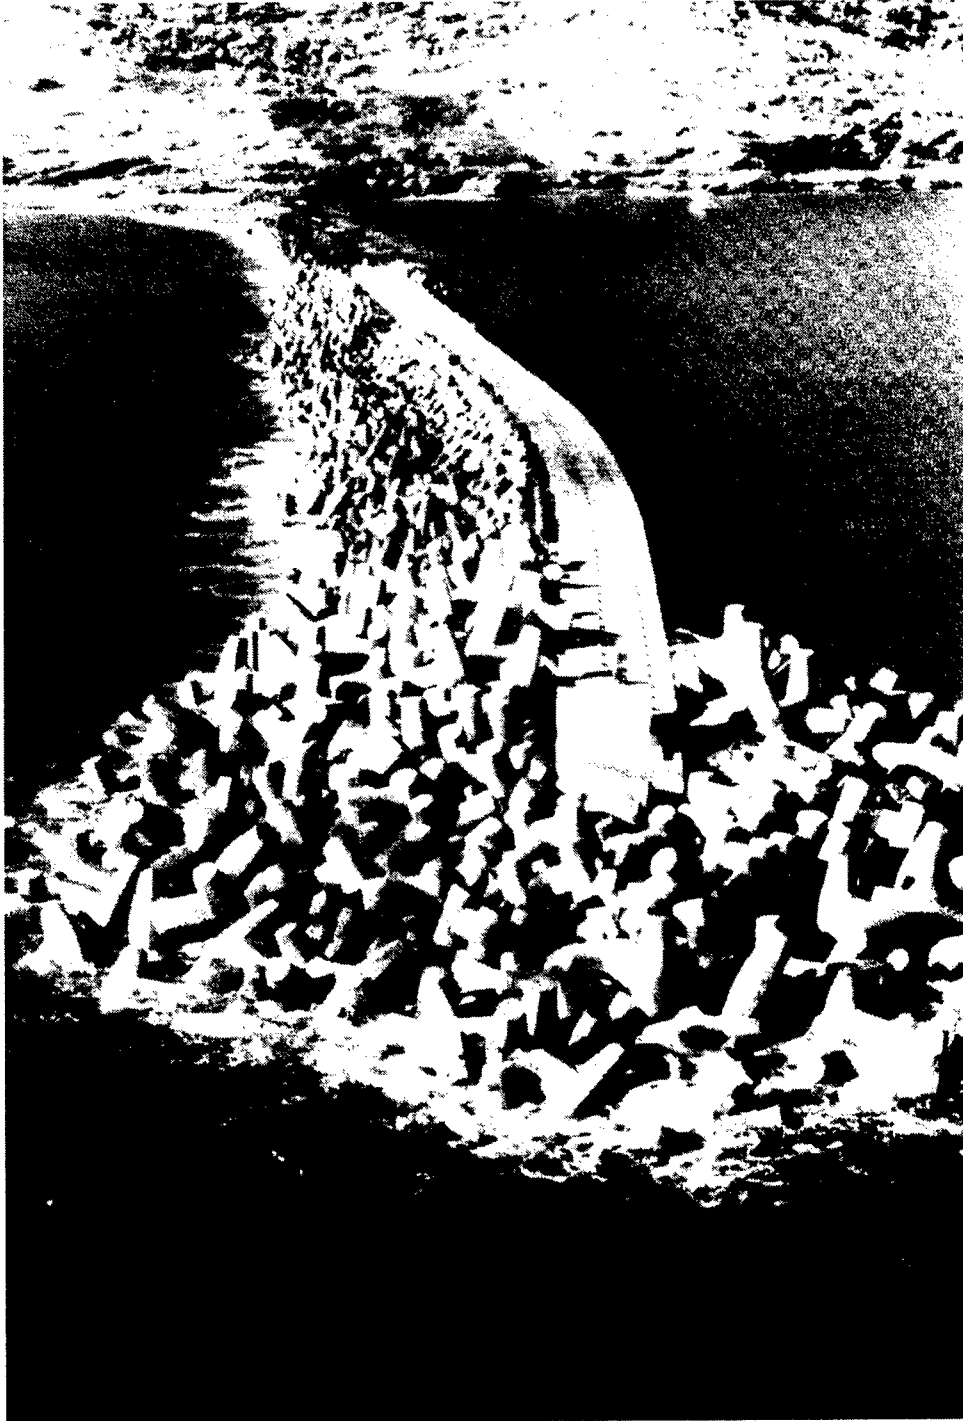
Figure 8. Aerial photograph of Nawiliwili breakwater (1995)

Initial monitoring of the Nawiliwili breakwater was completed in October 1995 as part of the "Periodic Inspections" work unit of the MCNP Program (Bottin and Boc 1996). Work included armor unit targeting, limited ground surveys, aerial photography, photogrammetric analyses of armor units, and a broken armor unit survey. The information obtained during the monitoring effort established base level conditions for the breakwater. Precise positions of targeted armor units were obtained as well as centroid data and orientations of the targeted armor units. The broken armor unit survey revealed that 70 broken/cracked armor units existed on the structure. An aerial photo of the Nawiliwili breakwater in 1995 is shown in Figure 8.

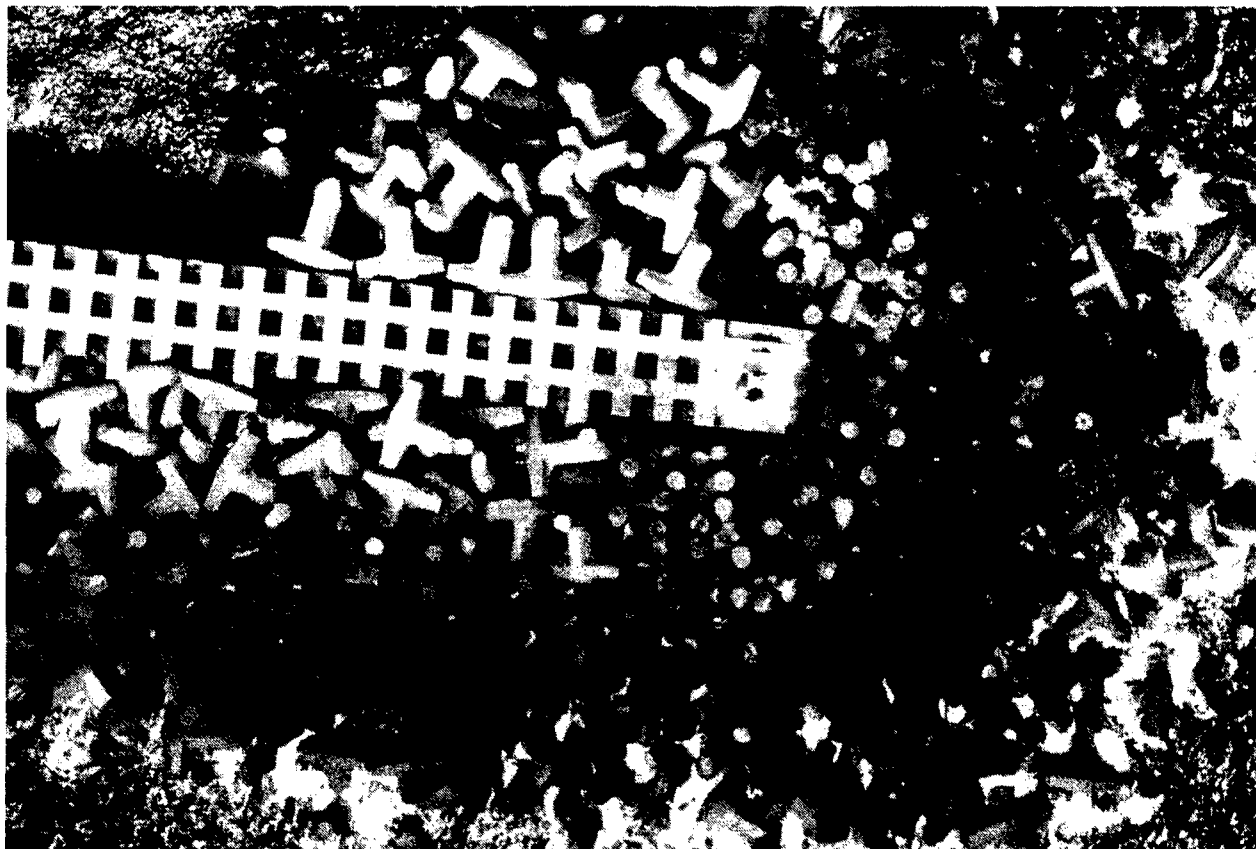
Figure 17. Photo map of head of Nawiliwili breakwater

Photo maps combine the image characteristics of a photograph with the geometric qualities of a map. The image is rectified and free from skewness and distortion, and therefore, precise horizontal measurements may be obtained using an engineer scale. Photo maps were prepared for the outer 260-m (850-ft) length of the Nawiliwili breakwater for the 2001 survey. They were produced on Mylar sheets at a scale of 1:240. An example of a photo map of the head of the Nawiliwili breakwater is shown in Figure 17. In an effort to quantify movement of nontargeted concrete armor units, photo maps obtained for the 1995 and 2001 surveys were compared. It appeared that negligible movement of nontargeted units had occurred between the surveys.

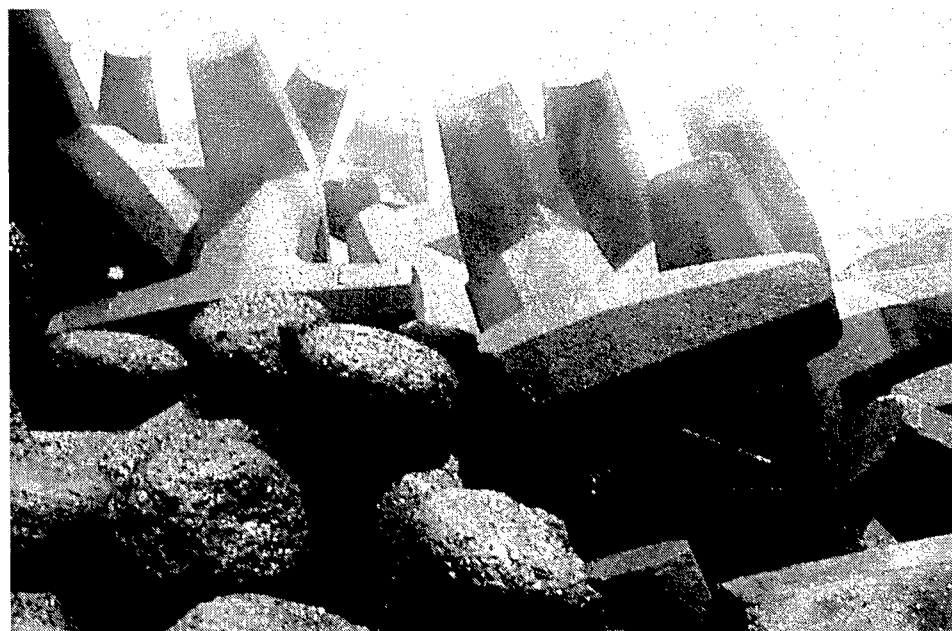
Types of breaks for the dolosse included shank and fluke breaks. These were characterized as mid-shank, shank-fluke (shank broken in vicinity of fluke), and fluke-shank (fluke broken off at junction with shank). Also recorded were straight breaks (broken straight across) and angled breaks (broken at some angle to the dolos limb). For the tribars, types of breaks included those through the center section of the unit where one or more legs were separated from the unit, and those in which just a portion of one of the legs was broken off. Views of representative types of breaks for the armor units are shown in Figures 19-22. Armor units with hairline cracks on one side were not counted, only those that were cracked all the way through were considered a break for recording purposes.

Figure 20. Dolos with fluke-shank break

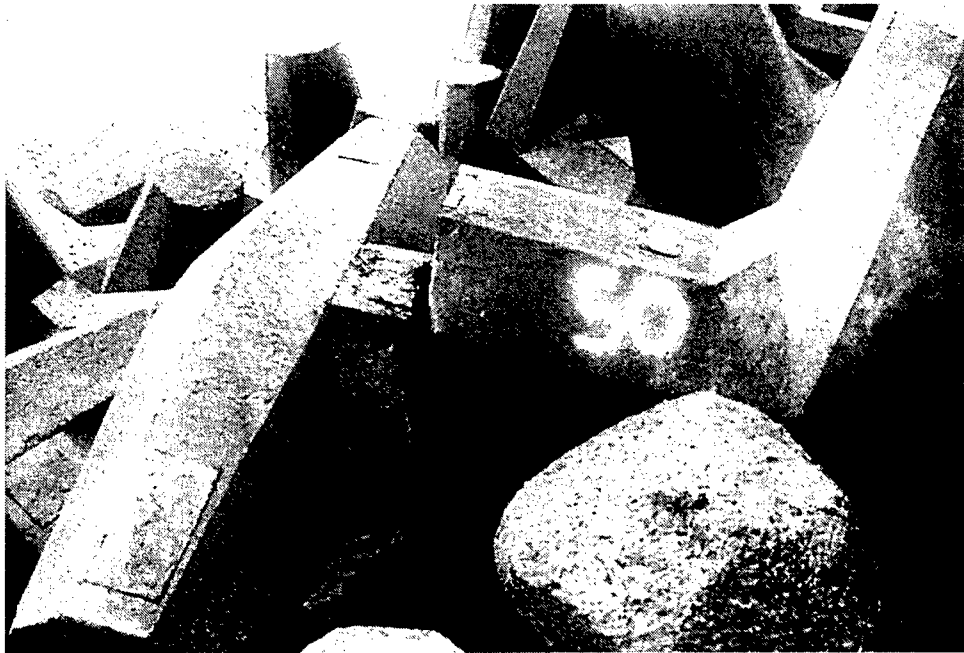
Figure 21. Dolos with shank-fluke break
